# Electrosonics Building Renovation and Remediation

Dennis Chase | Jayleigh Genest | Paige Hornbeck | Mason Pillsbury | Jacob Ritchie  
Civil and Environmental Engineering, University of New Hampshire, Durham, NH 03824

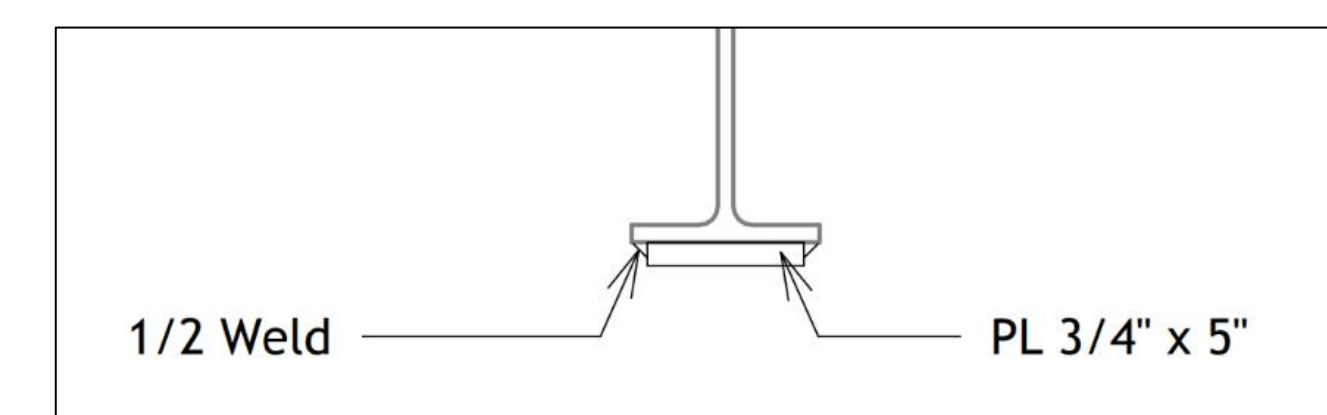
Existing W section Carnegie Steel B3 Beam

$$\Phi Mn = 260.5 \text{ k} \cdot \text{ft}$$

Z = increases from 145 in<sup>3</sup> to 179 in<sup>3</sup>

Reinforcement to strengthen the existing steel beams

Existing W section with 5" x 3/4" plate welded to the bottom

$$\Phi Mn = \frac{36 \text{ ksi} (179 \text{ in}^3)}{1.67} = 321 \text{ k} \cdot \text{ft}$$

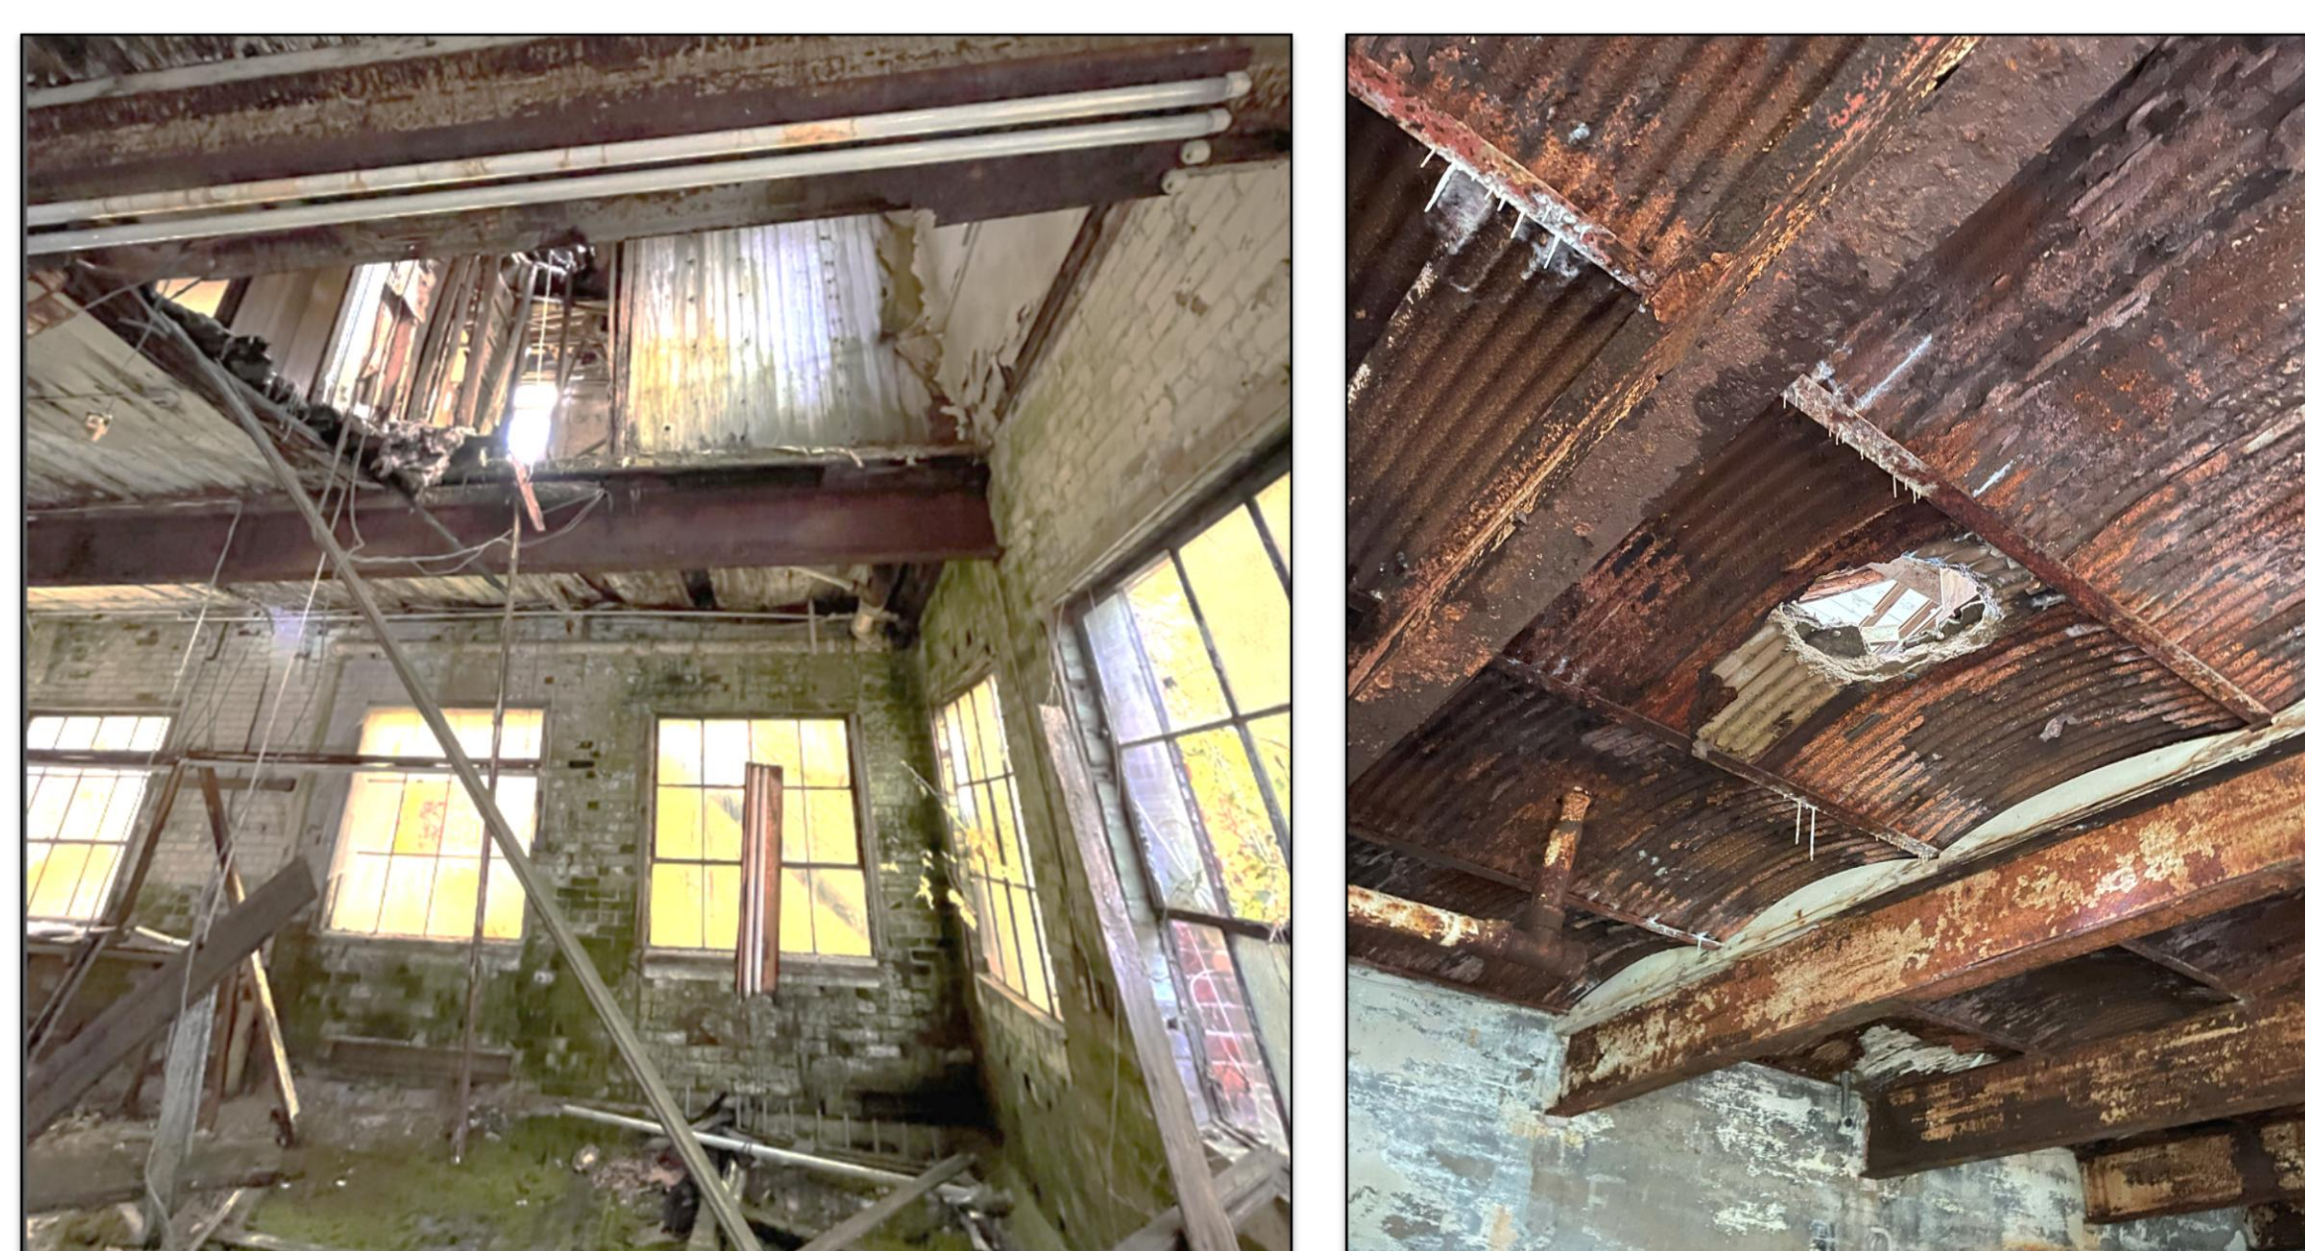
The structure has extreme deterioration, including corroded metal decking, rotting wood framing, and toxic organic growth on the brick masonry. Testing found bulk moisture, asbestos, lead paint, and PCBs within the building. The site has severely limited space, posing challenges for site expansion.

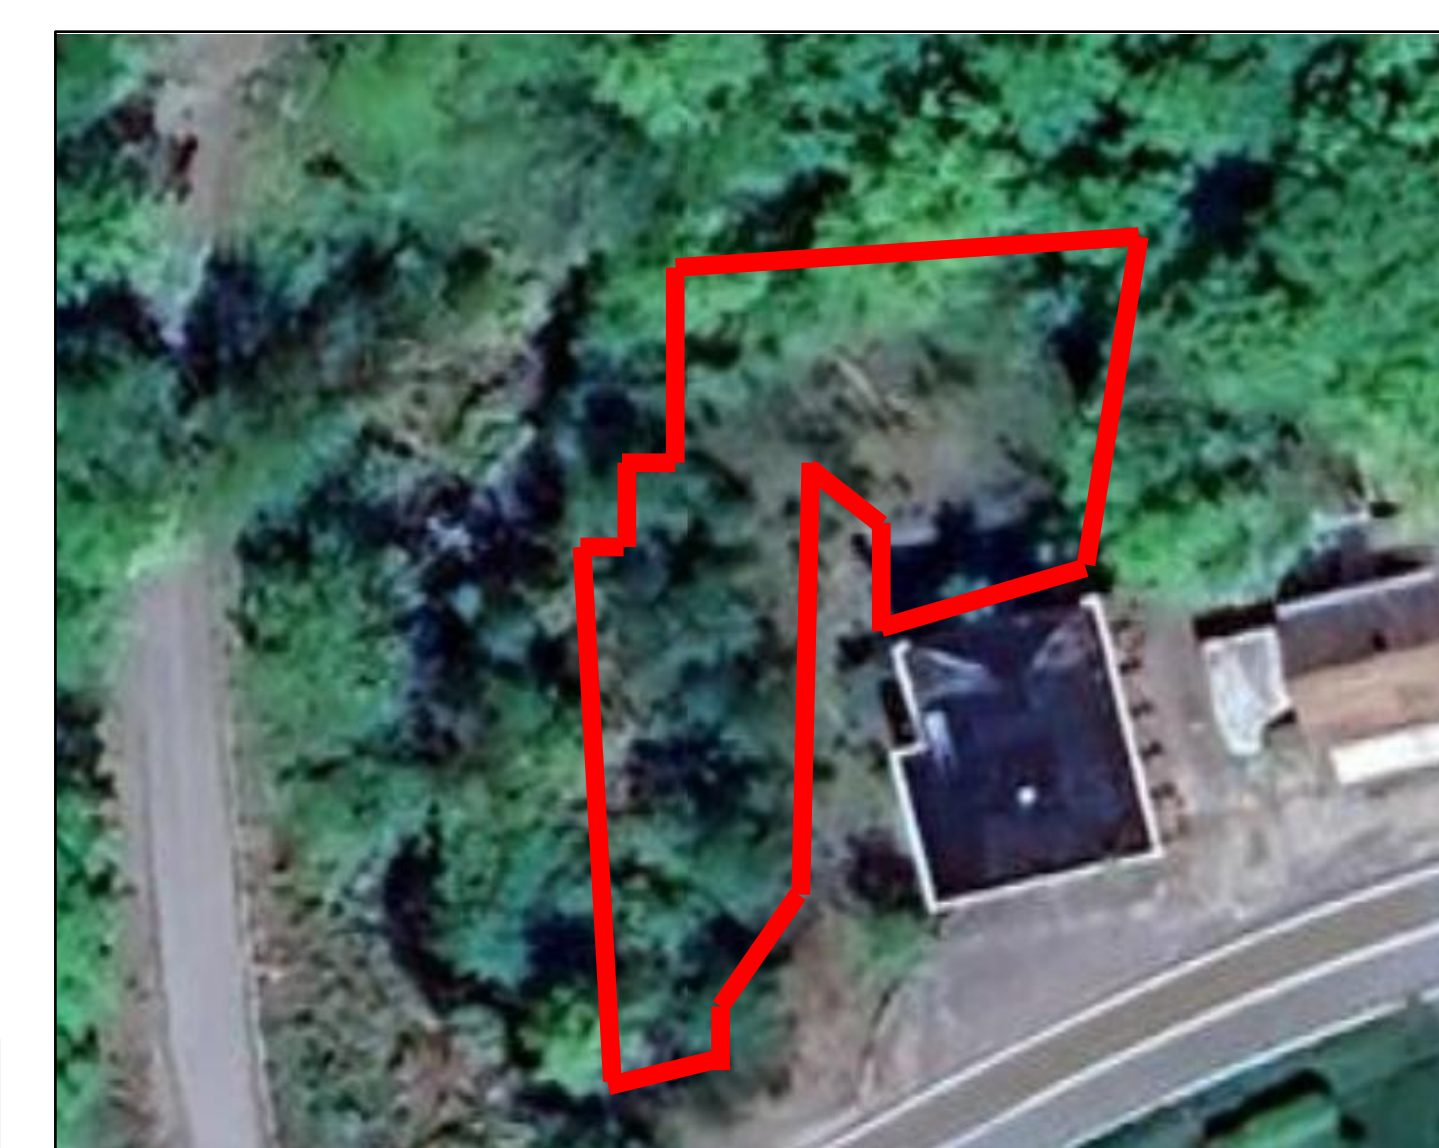
The building has had multiple prior usages resulting in significant quantities of electroplating metals and solvents being discharged into the ground and multiple fuel oil spills. The surrounding soils and ground water are contaminated with cVOCs, RCRA metals, and petroleum. Below outlines the recommended remediation process.

Google Earth image with marked areas of concern proposed for excavation
