Analyzing and Redesigning Housing for Pressure and Temperature Sensors

Project Objectives

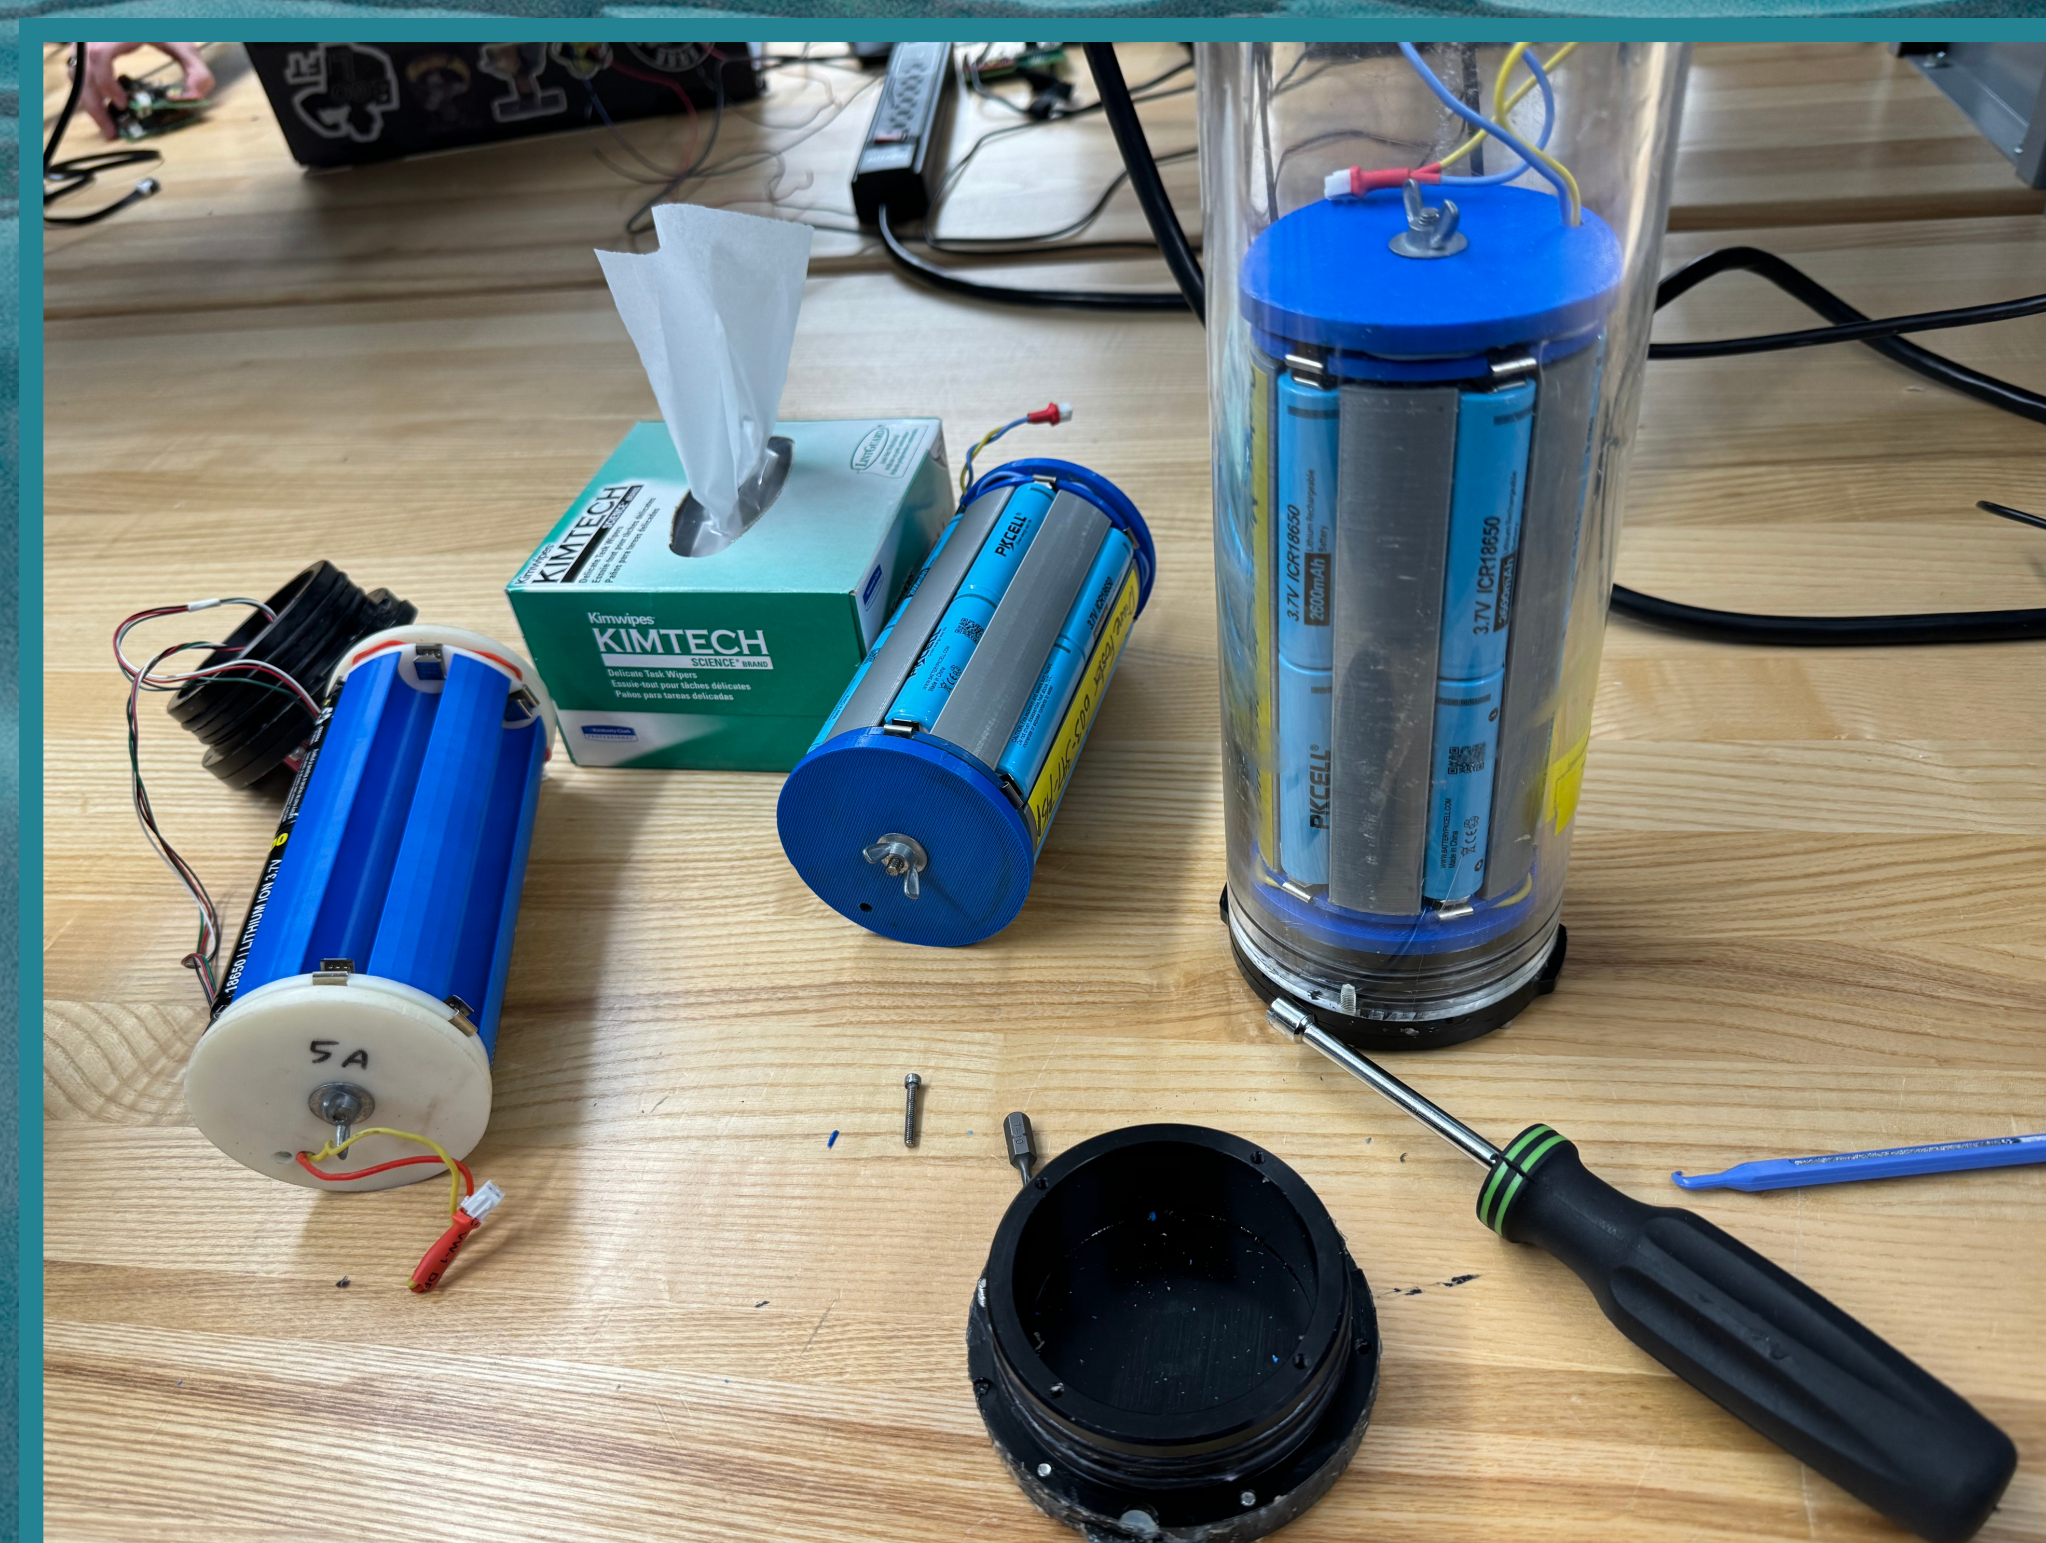
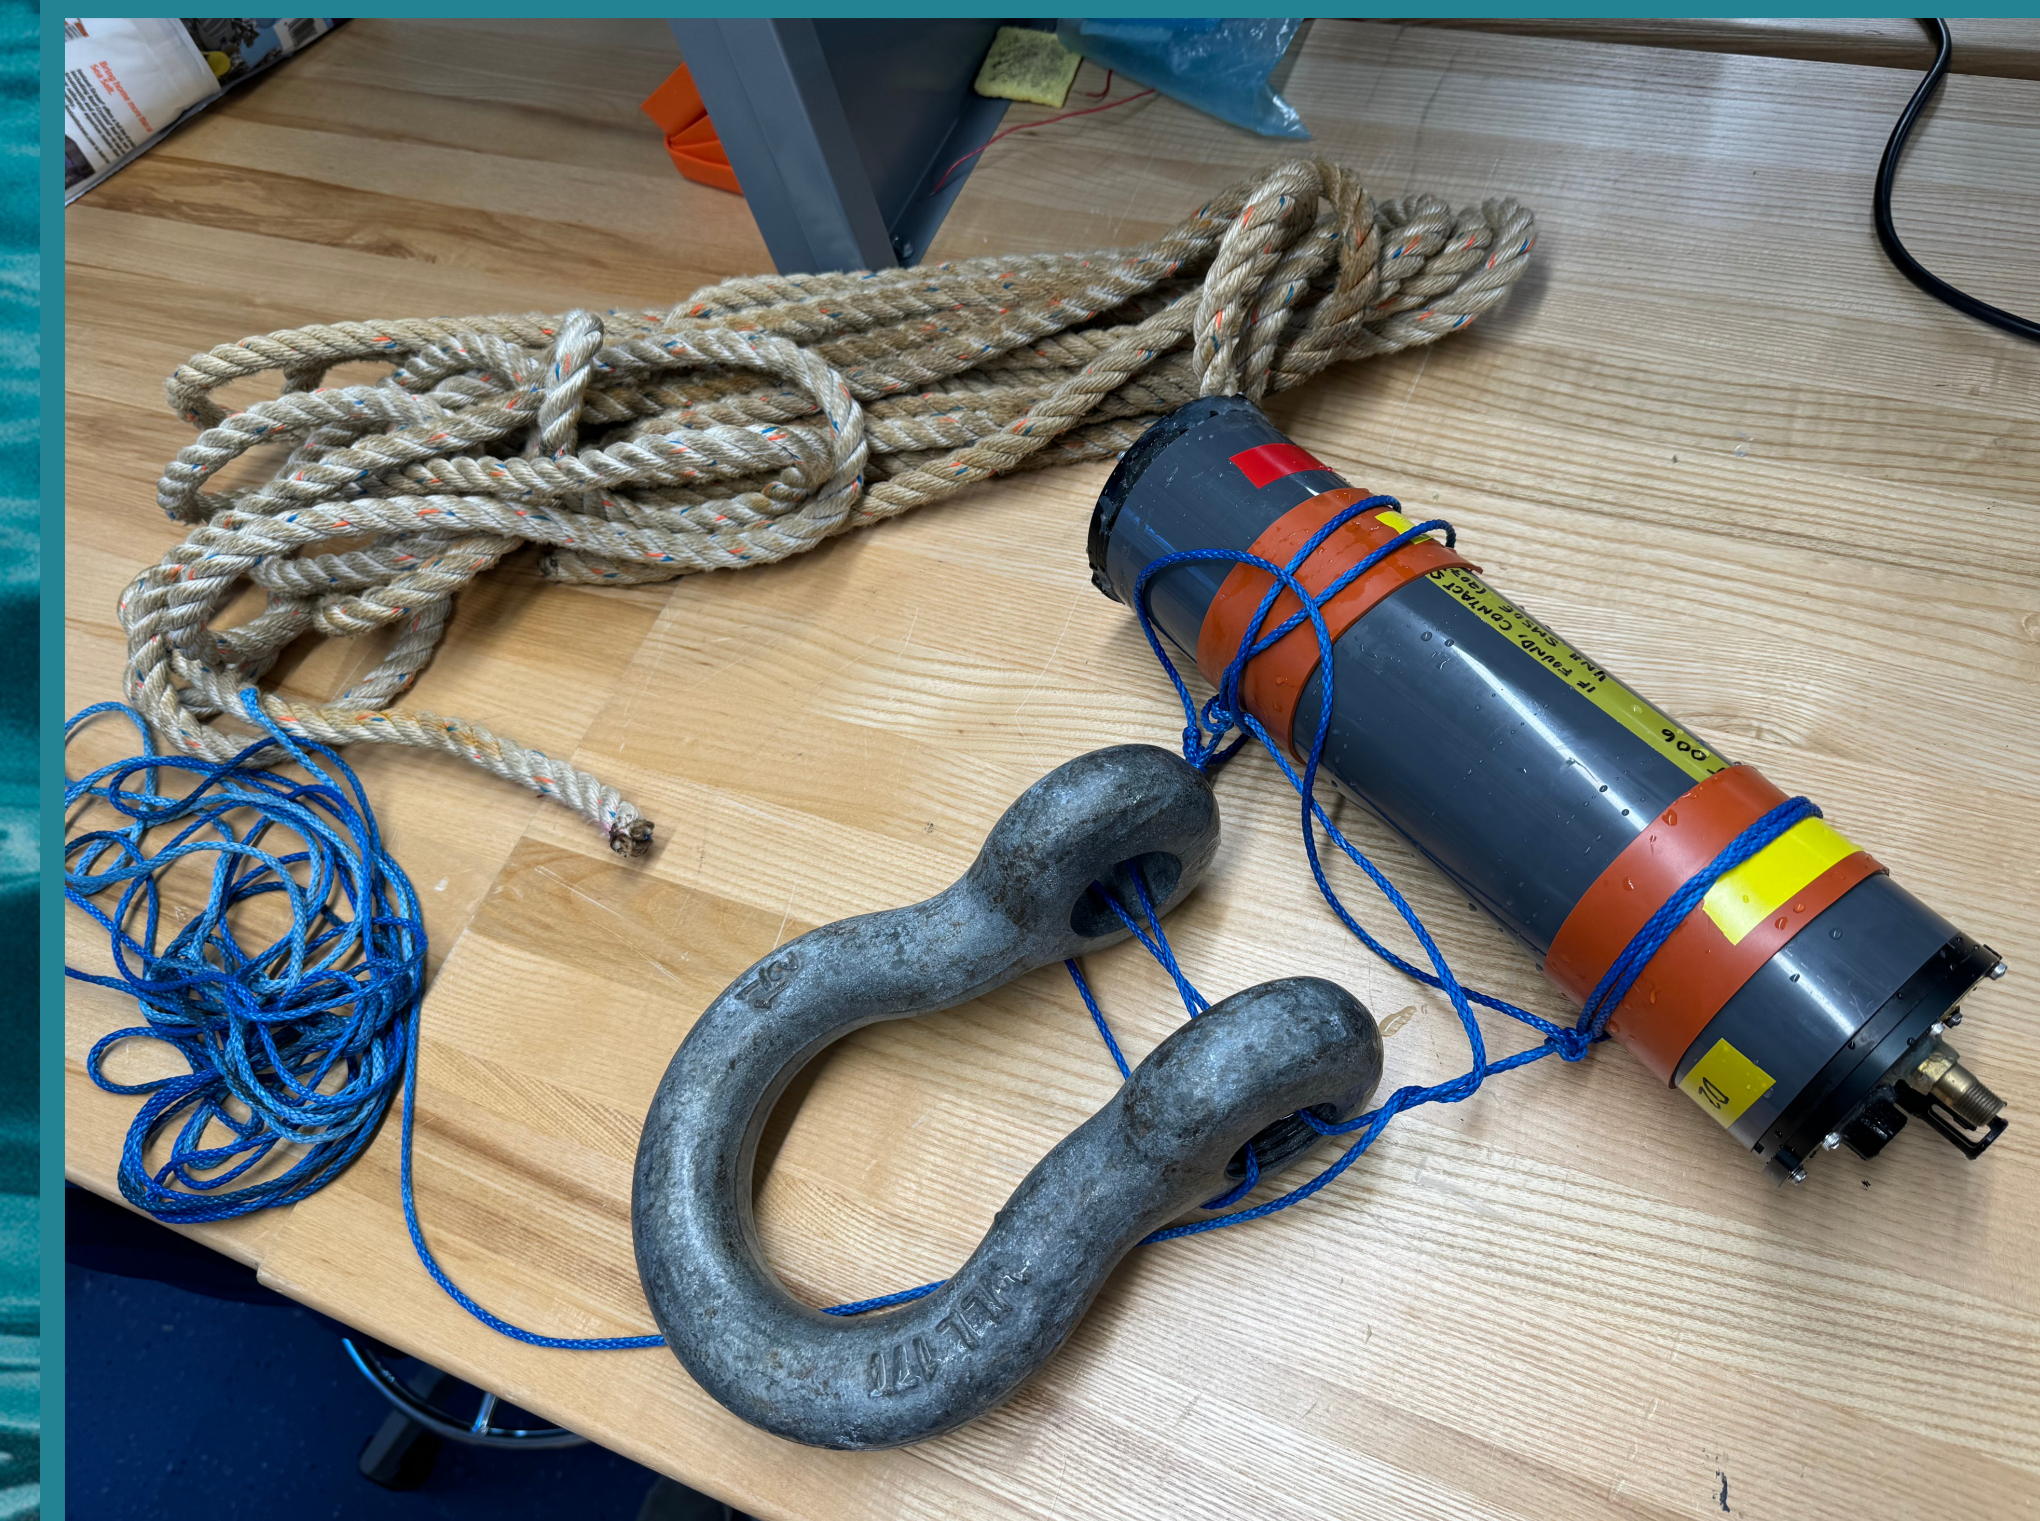
- 3D Printing:
 - We printed multiple test models
- Who we collaborated with/got guidance from:
 - Dr. Fredriksson gave us guidance on how to take apart and reassemble the housings properly. For example, the caps needed o-ring grease for the o-rings in it, so he showed us how much to add and how clean to keep it.
- Testing:
 - First we reassembled the old housing units according to Dr. Fredriksson's instructions, added weights to them, and dunked them in a water tank. From this we found that loose screws let water leak in, but this seemed to be the only problem (we had redone the o-ring grease correctly).

- Trial and Error:
 - We needed to take a lot of measurements of the different pieces of the housings so that we could 3D print a model that would fit the battery, circuit, etc.
- The first printing went wrong since the file has incorrect dimensions, then we fixed this and tried again. From this we got a more suitable housing unit, but the printing filament shrunk as when it printed so the batteries didn't fit.
- What went wrong with the original housings:
 - Too much o-ring grease was used
 - The screws holding the lid to the main body were loose, this resulted in water leakage and sand getting in the o-ring grooves.

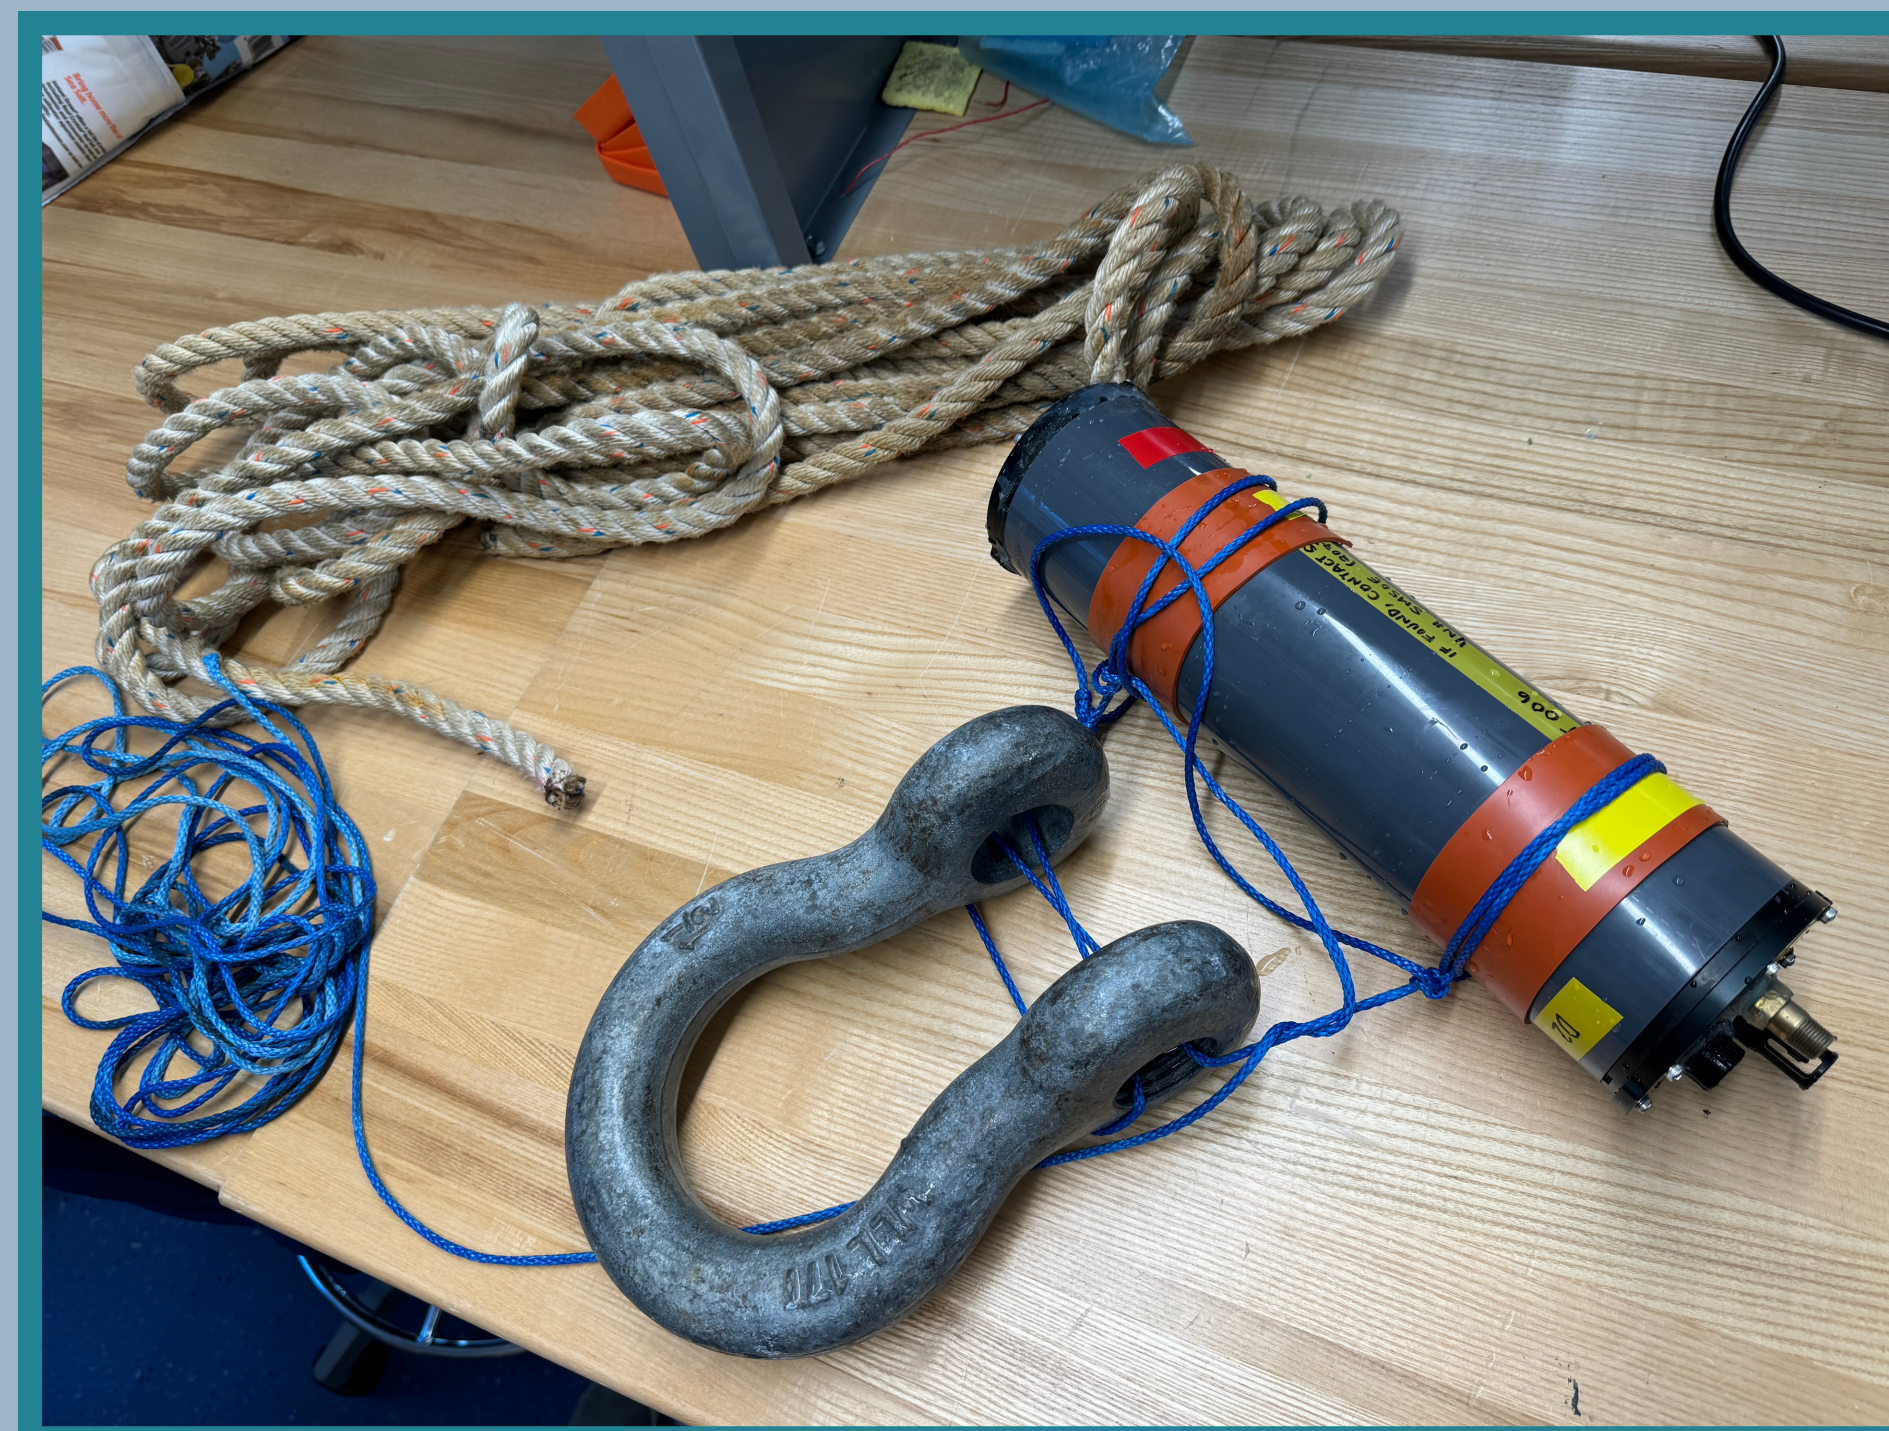
- SolidWorks and a 3D Printer were used to make multiple housing models

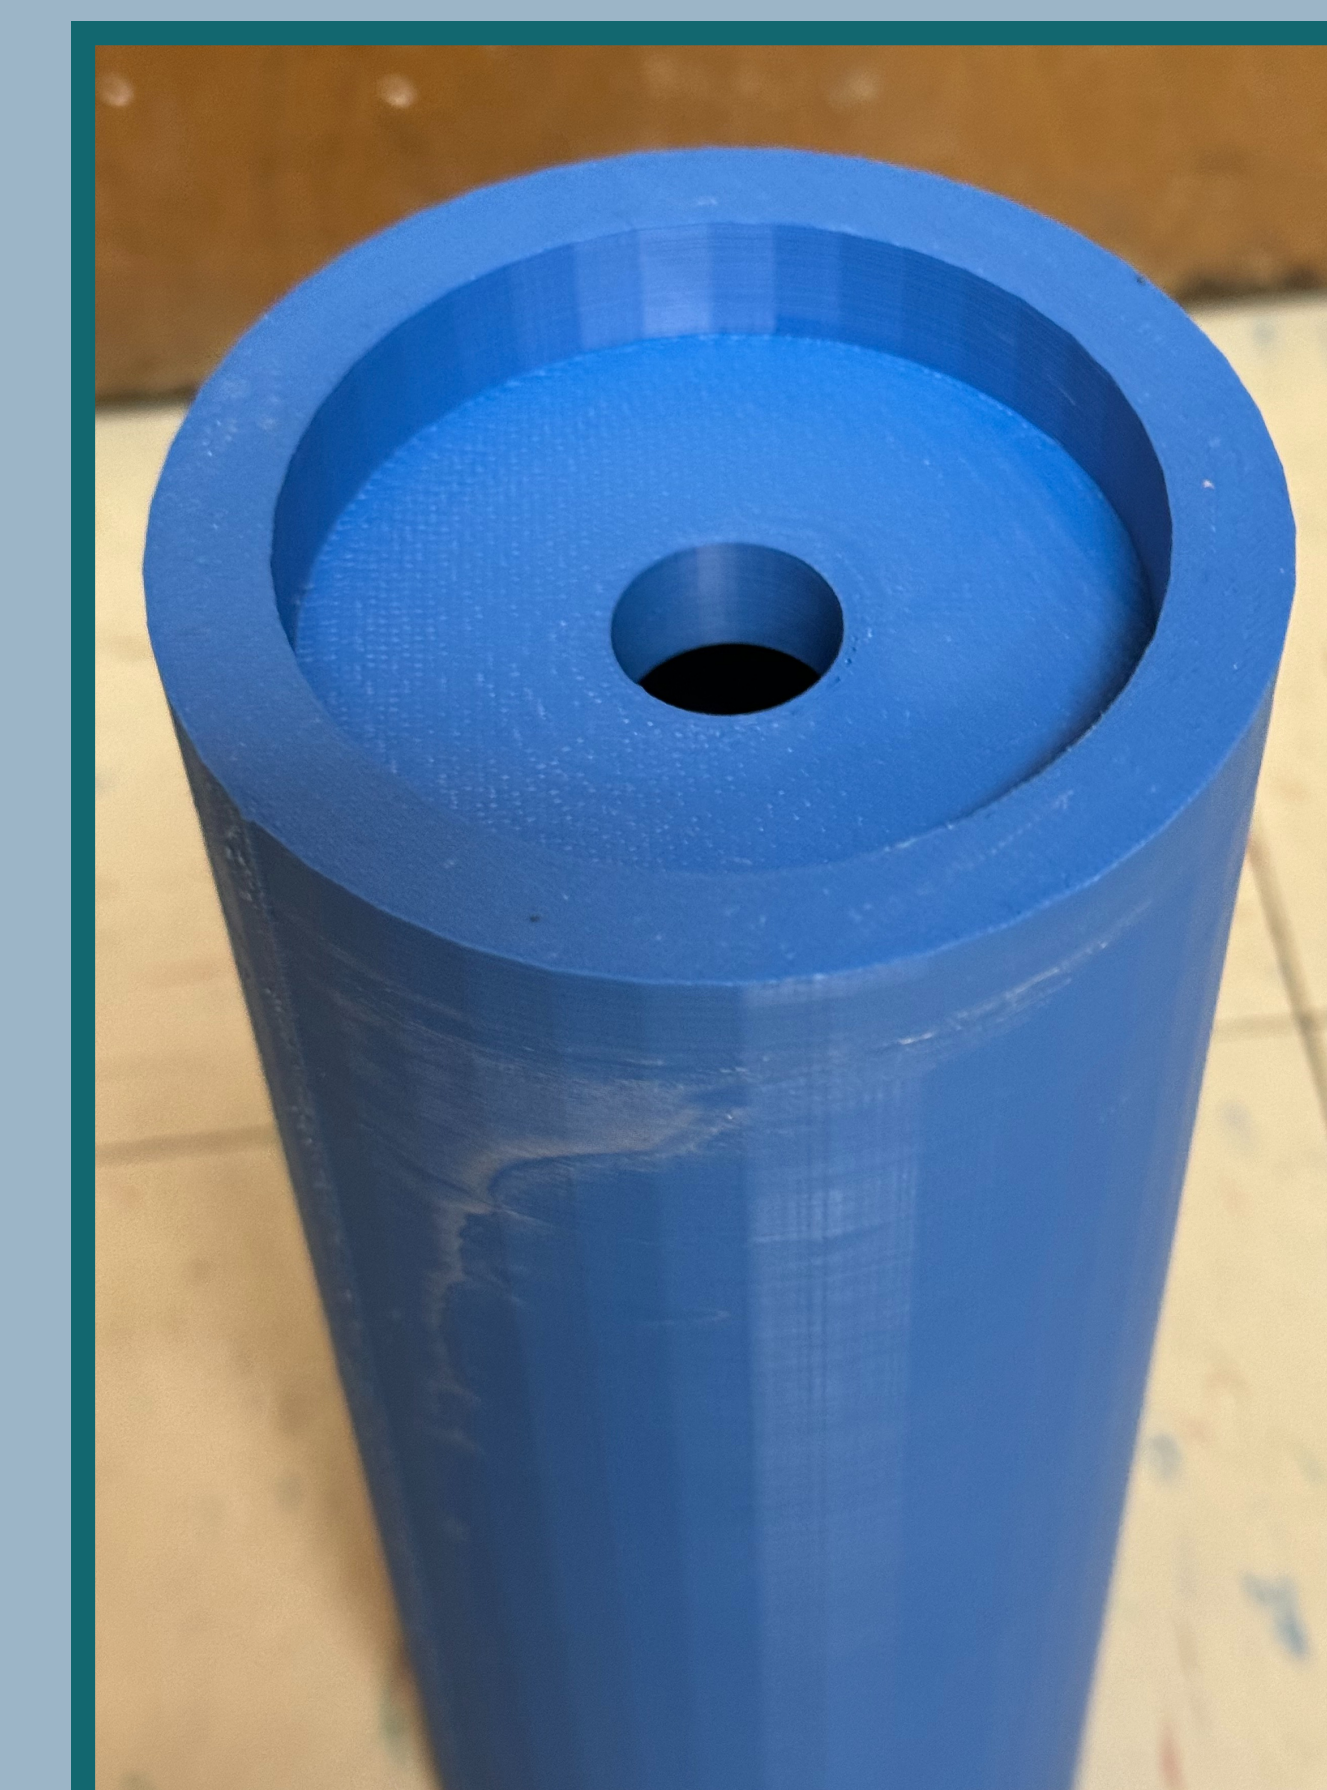
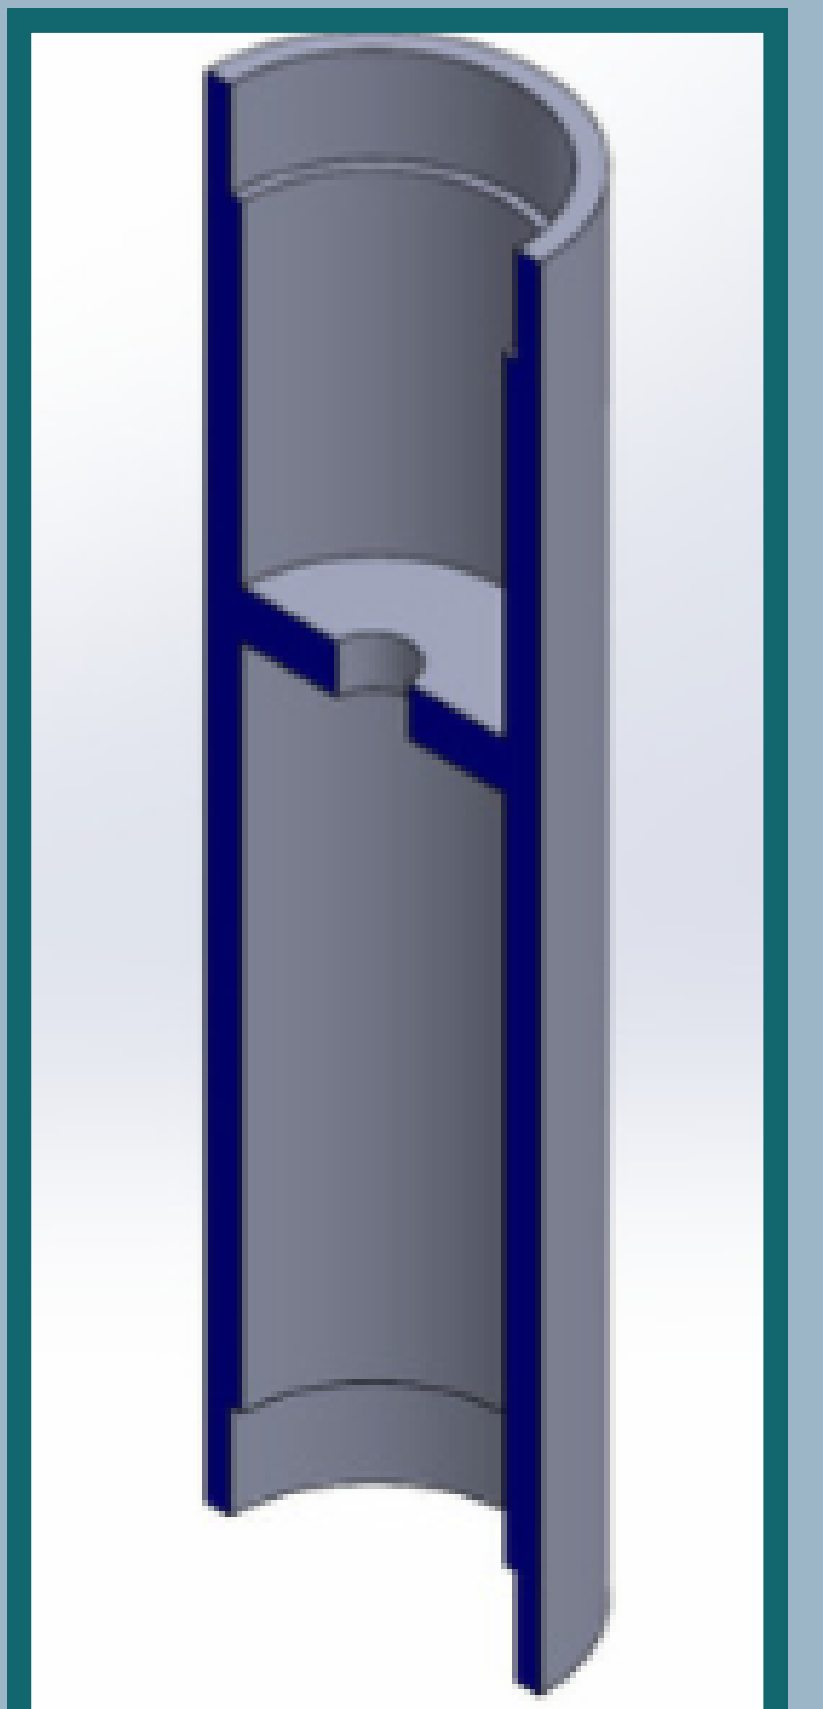
- Testing of the original model in the Chase tank
- It was found that the housing did leak due to loose screws and too much o-ring grease
