Evaluation of Sunny Day Flooding at Hampton Beach, New Hampshire

University of New Hampshire
College of Engineering and Physical Sciences

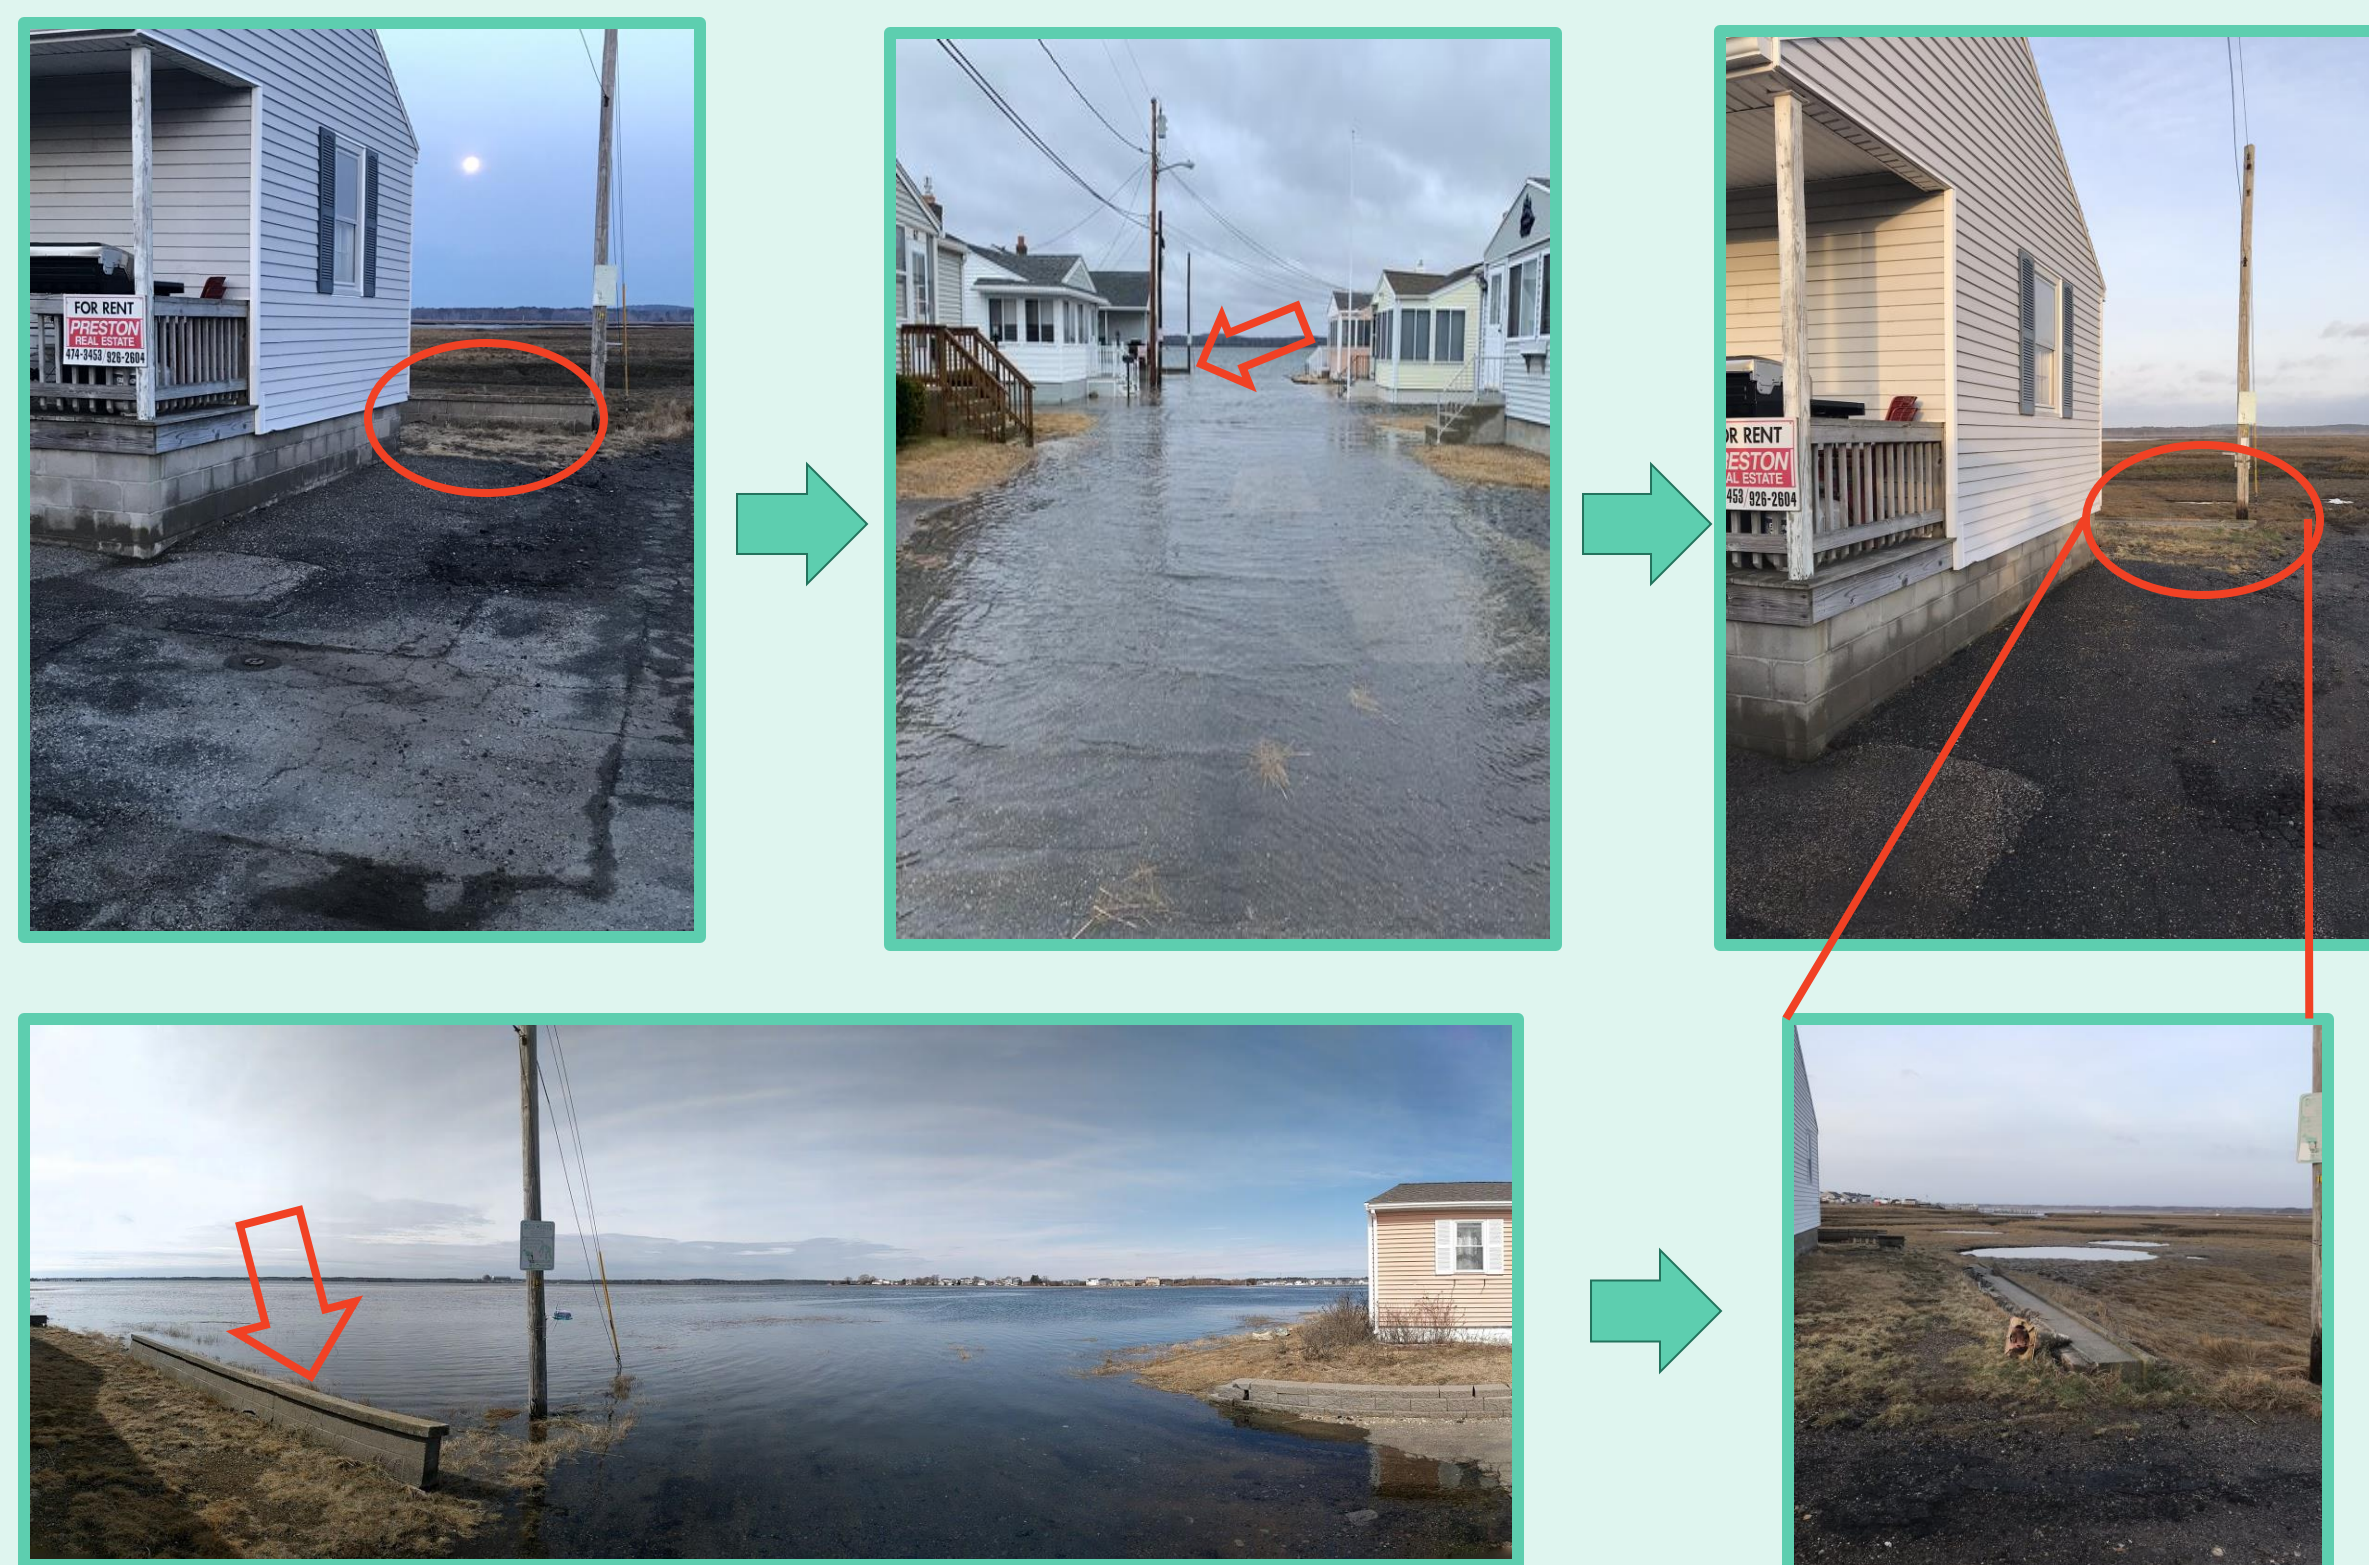
The pictures above show some of the damage these tides have caused. When the sensors were first deployed, a barrier wall was in tact but when we visited later, the wall had been knocked over and destroyed.

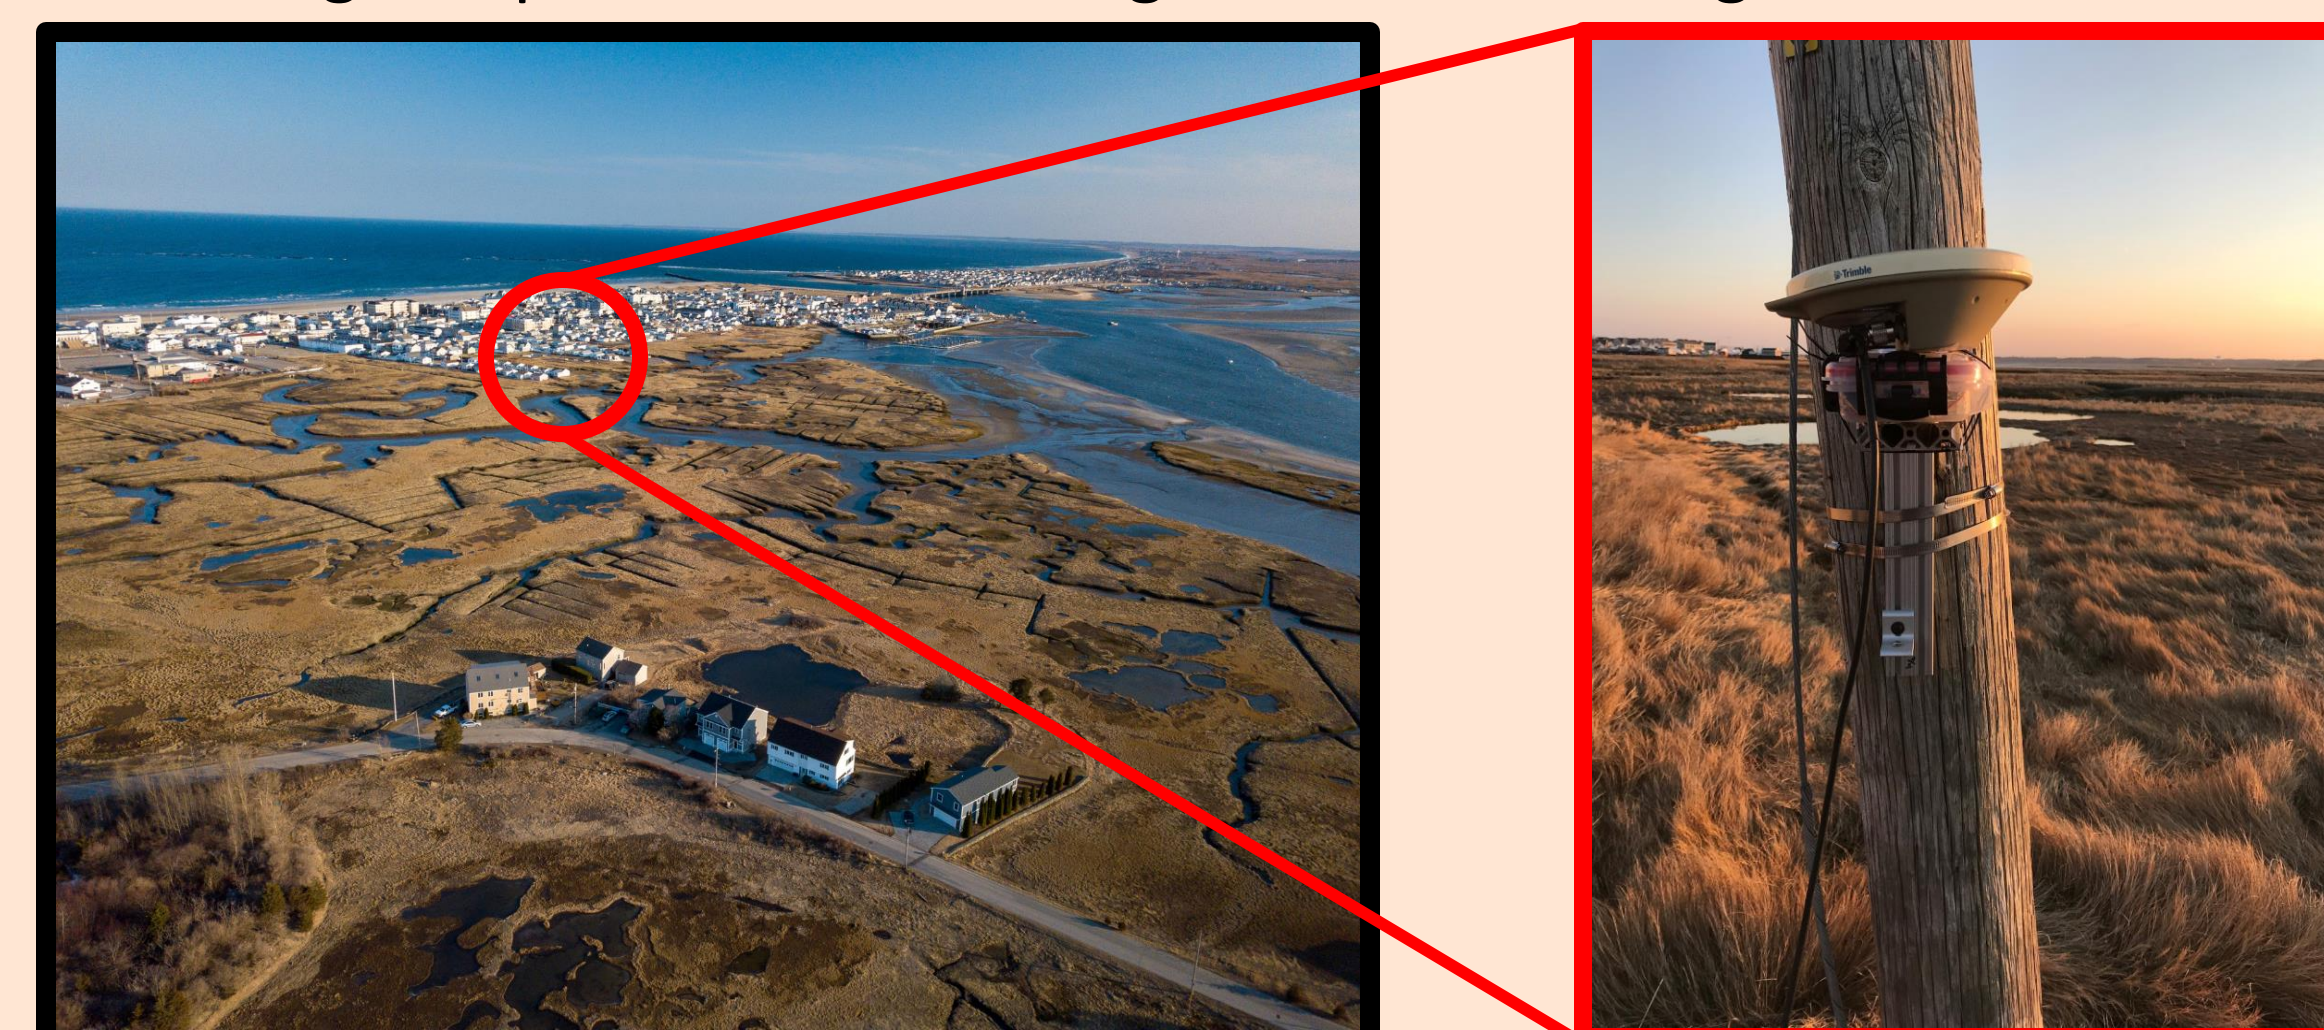
The pictures above show the location of sensors on Hampton Beach

Hobson Ave. is one of the local Hampton streets that sees regular flooding. Due to its low elevation, Hobson Ave and Hampton Beach as a whole are great places to study the flooding not only for the effects it has on the area, but for understanding this phenomenon on a global scale for larger cities.

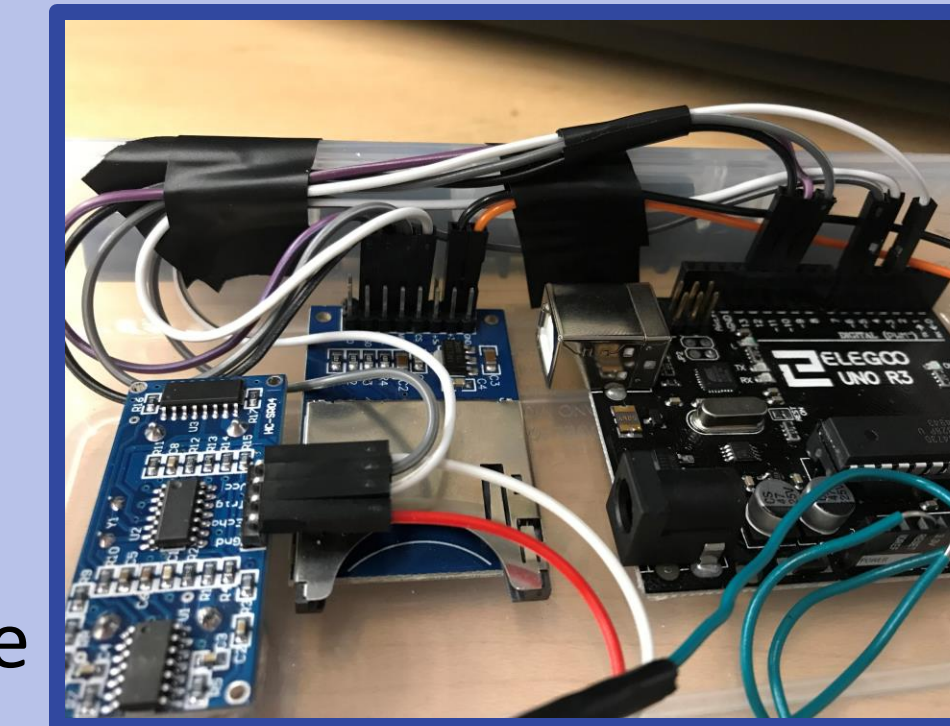
An ultrasonic sensor was used to measure the distance from the sensor to the ground. As the water levels rose, the distance that the sensor read decreased, allowing us to calculate how high the water rose. Since the sensor is near the water and must endure the field conditions, a case was needed for waterproofing.

The instrument package contains:

- Arduino
- Ultrasonic sensor
- SD card reader & SD card
- Breadboard and breadboard leads
- 9V battery (Replaced by portable phone charger)
- 80-20 aluminum brackets for mounting

The original 9V batteries only collect data for a few hours, but after switching to portable 10,000 mAh phone chargers as a power source, the battery lasted for over 4 days.

The sampling frequency of the ultrasonic sensor was set to once per minute to resolve the tide over the four day window.

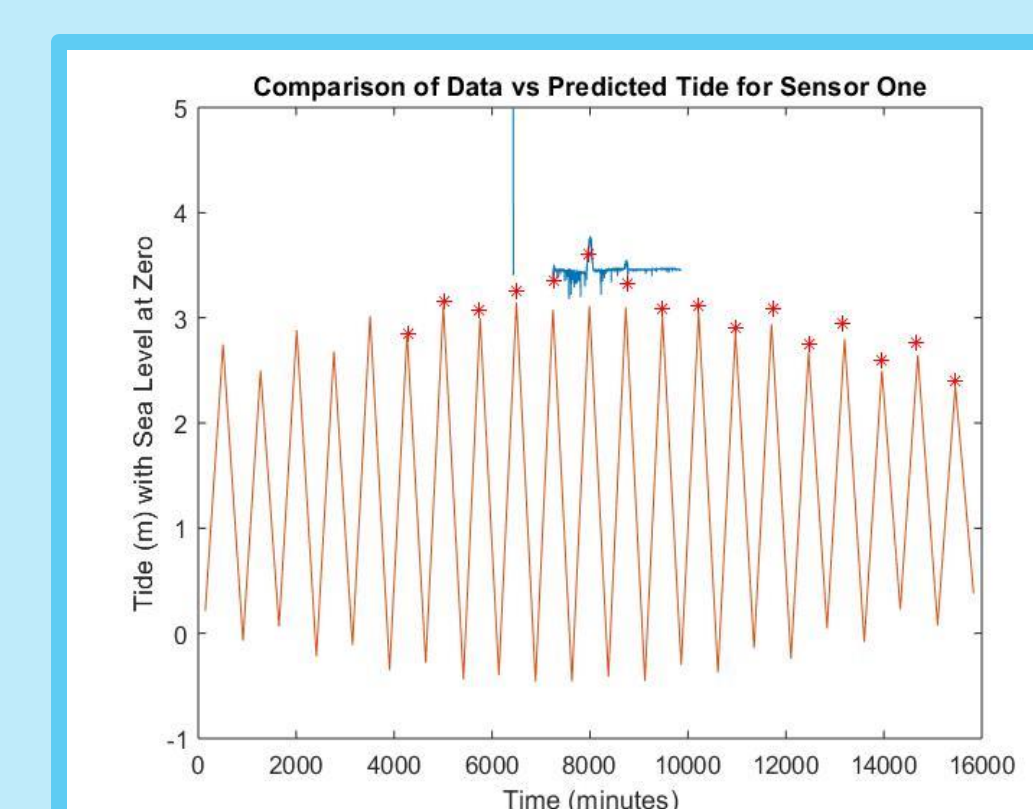
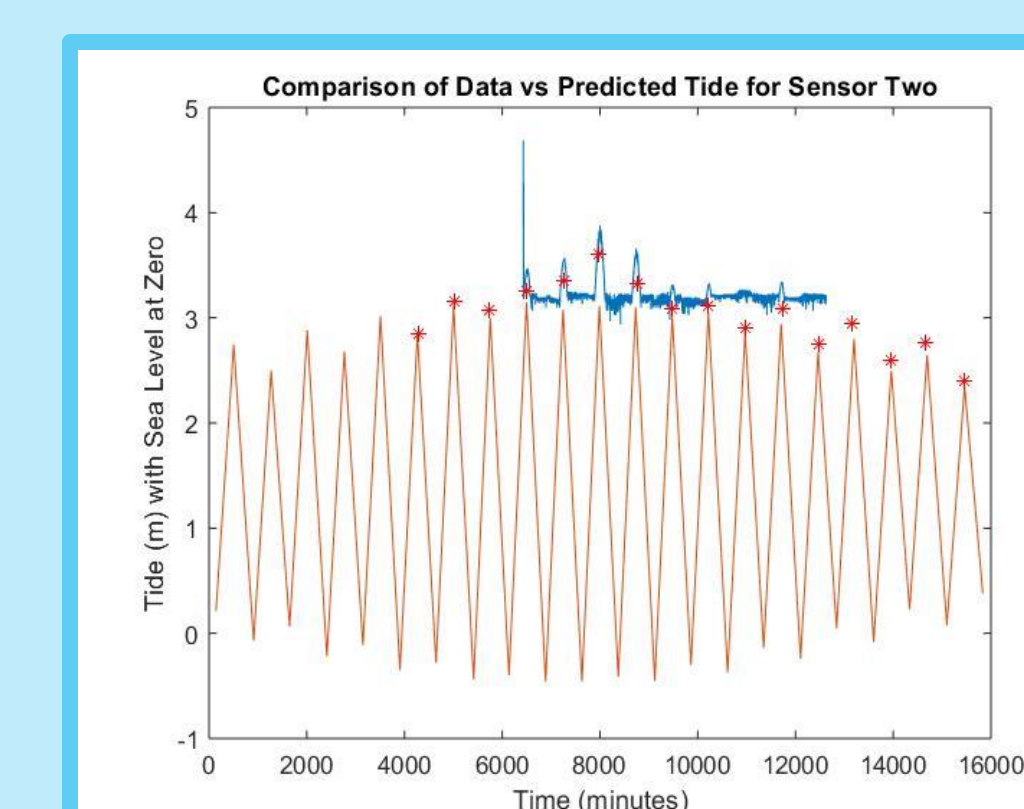
The following graphs show the measured water level (blue), from our sensors, predicted tides (orange), taken from tidesandcurrents.NOAA.gov for Hampton Bay, and recorded highest tides (red stars), from Hampton Tide Gauge 2, over a four day window. The highest predicted tide was 3.14 meters above sea level, while the ground below our sensors were 3.54 and 3.22 meters above sea level based on our survey data. The ground height above sea level was considered for the recorded data in the plots, which shows that the flooding for the March king tide was approximately 0.7 meters higher than predicted (based on our recorded data). Sensor one was further up the road, which is visible in that sensor two caught more high tide moments, as the water did not always reach sensor one. While the tide did reach about 0.7 meters higher than predicted, it is important to know that during this particular king tide there was also a storm surge.

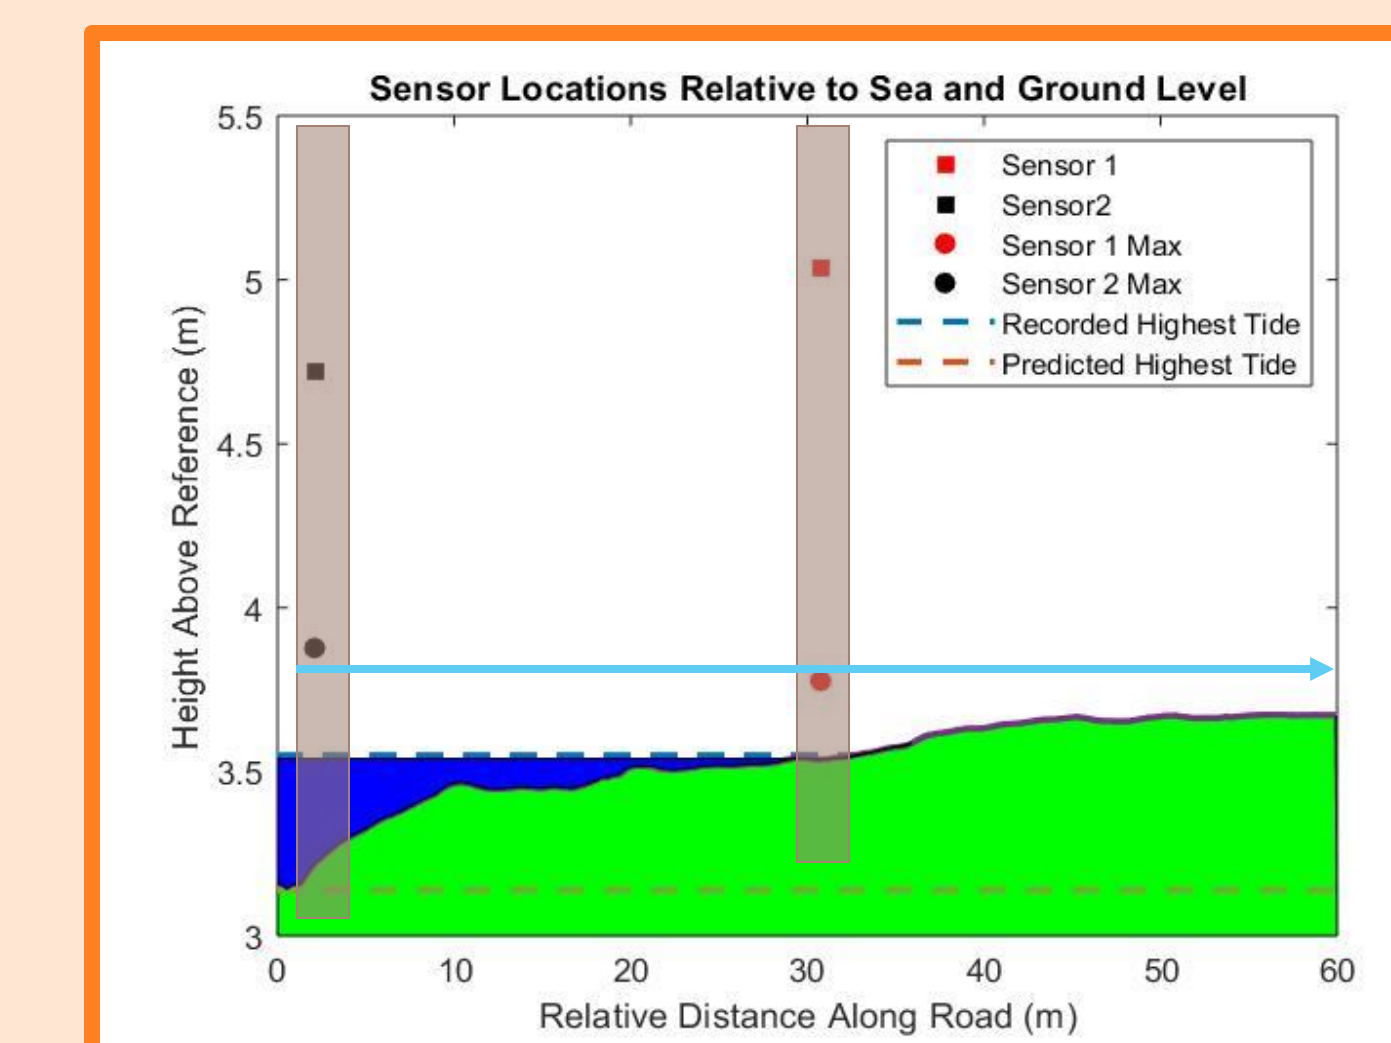
The graph below shows the maximum water level along Hobson Avenue. The reference elevation is 0 at sea level. The green represents the topography of the land on which the data was taken, and the blue is the maximum recorded water level from Hampton Tide Gauge 2. The maximum water level observed at each location, corresponding to our measured data are shown as black and red circles, and the blue arrow denotes the average.

The graph above shows that the predicted tide level is lower than the observed water level. The picture on the above right shows that at high tide, Hobson Ave. was completely flooded. The arrow on the picture shows the sensor locations. The water level predicted by the tidal model would have only reached sensor 1, but our observations and the photographic evidence show that the total level was significantly higher, resulting in the flooding of the entire street.
